Remedial Investigation/Feasibility Study  
Analysis Asphalt Storage Area, Elmendorf  
AFB, AK

M.S. Environmental Engineering  
University of Texas at Austin

**Departmental Report**

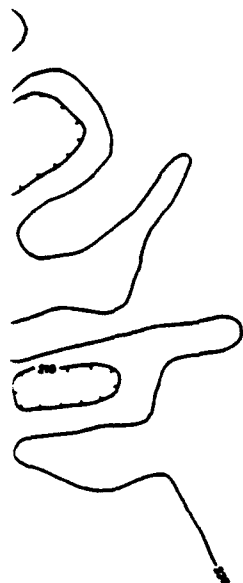
Figure 5: Asphalt storage area map showing work areas and  
(adapted from EA Engineering, Inc., 1993)

3 and features

Also, during the Phase 1 investigation, 21 additional drums were found which contained materials other than asphalt. These drums were found in Areas 9, 21, 24, 28, and 31. These drums were placed in overpack containers and transported to Area 3. These drums will be sampled and analyzed according to ADEC requirements when additional funds are available. After complete characterization, they will also be classified as either hazardous or nonhazardous waste, according to 40 CFR Part 261, and transported to the EAFB TSD facility for appropriate disposal based upon the waste classification.
